Manhole Inspection Summary

Manhole # S53A__027MH

Inspection ☐ Is Incomplete Rating: **3) Fair**

Location Address: **3250 pulski h3y**

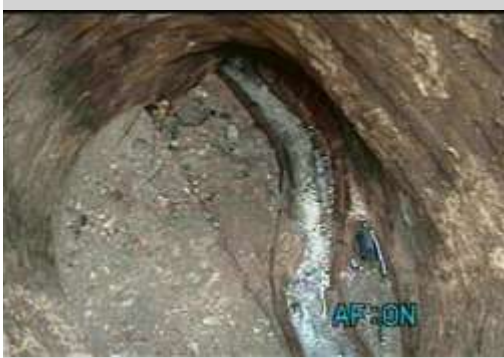
Defect 1

Condition: ☐ Sound ☐ Cracked ☐ Root Intrusion ☐ Loose Brick ☒ **Deteriorated**

Infiltration: ☐ None ☐ Joint ☐ Cracks ☐ Mortar ☐ Roots ☒ **Wall**

Condition: ☐ Sound ☐ Cracked ☐ Root Intrusion ☐ Deteriorated ☐ Leaks ☒ **Debris**

Deteriorated Corbel, Bench Debris,
Corbel Infiltration

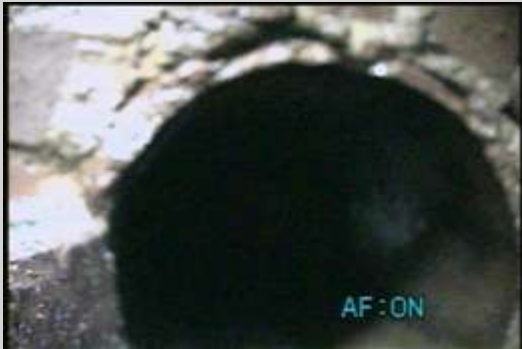
12 O'Clock Outflow

8 in. Circular Gravity Sewer
Pipe Out @ 12 O'Clock

Invert Depth: **9.20** (ft.) Flow Characteristics: **Slow**

Deposits: ☒ None ☐ Mud ☐ Sludge ☐ Debris ☐ Grease

Infiltration: **None** Pipe Seal Cond: **Unknown**

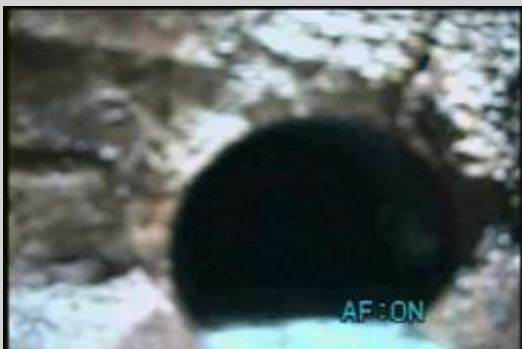
6 O'Clock Inflow

8 in. Circular Gravity Sewer
Pipe In @ 6 O'Clock

Invert Depth: **8.90** (ft.) Flow Characteristics: **Slow**

Deposits: ☒ None ☐ Mud ☐ Sludge ☐ Debris ☐ Grease

Infiltration: **None** Pipe Seal Cond: **Unknown**
